National Register of Historic Places Registration Form

Manning-Kamna Farm Name of Property		Washington Co., OR County and State		
5. Classification				
Ownership of Property (check as many as apply)	Category of Property (check only one box)	Number of Resources within Property (Do not include previously listed resources in the count)		
X private X building(s) public - local district public - state site public - Federal structure object		Contributing Noncontributing 10 buildings sites structures objects 10 Total		
Name of related multiple pro (enter "N/A" if property is not part of		Number of contributing resources previously listed in the National Register		
N/A		0

Located at 29375 NW Evergreen Road, the Manning-Kamna Farm is an ensemble of ten buildings on a 2.22 acre parcel located north of Hillsboro, in Washington County, Oregon, on a portion of the original C.D. Wilcox Donation Land Claim 59. The group consists of a farmhouse, barn, chop house, chicken house, potato shed, smokehouse, privy, canning shed, pumphouse, and garage. The Manning-Kamna Farm retains buildings dating from the late nineteenth and twentieth centuries that related to and are demonstrative of both the agric

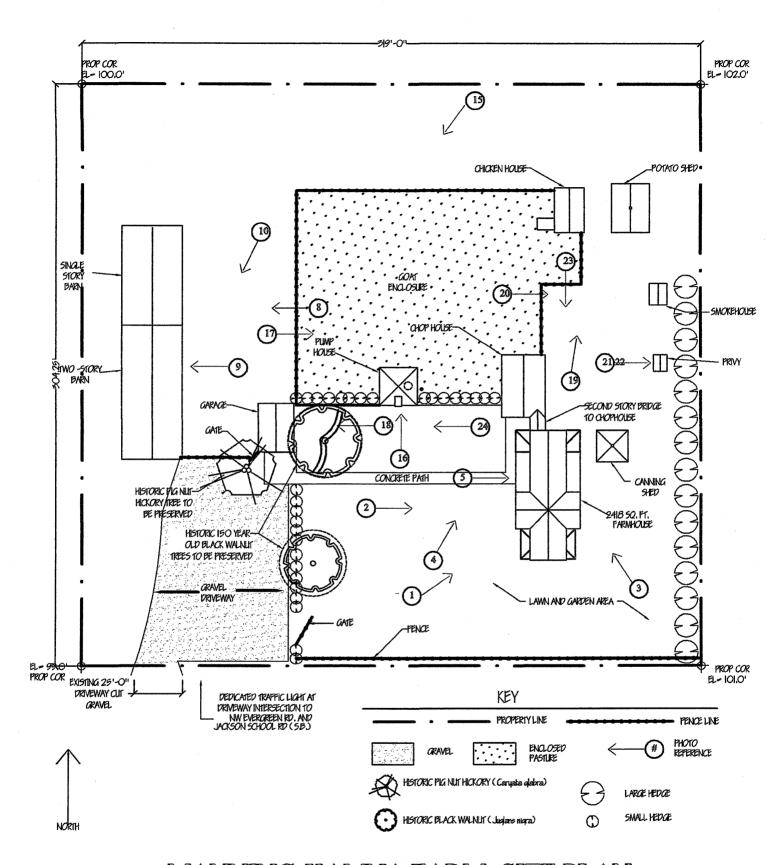
MANNING-KAMNA FARM: SITE PLAN

The Manning-Kamna Farm resides on flat land, and the building ensemble is laid out in a rectangular shape, bordered on the west by the barn, and on the east by a laurel hedge. The privy and the smokehouse are on the eastern edge of the ensemble. The canning shed is located between the house to the west and the privy to the east. The farmhouse is in the center of the ensemble, with the chophouse to the north, and the pumphouse and garage to the northwest of the gravel drive and parking area. The barn forms the western edge of the ensemble, and the northeast corner is formed by the chicken coop and potato shed, which is located north and slightly west of the privy. All of the buildings are organized along cardinal compass points.
